ABRASION ANALYSIS OF CRITICAL SLIDING COMPONENTS OF HYDROKINETIC DEVICES: AN EMPIRICAL STUDY

ABSTRACT

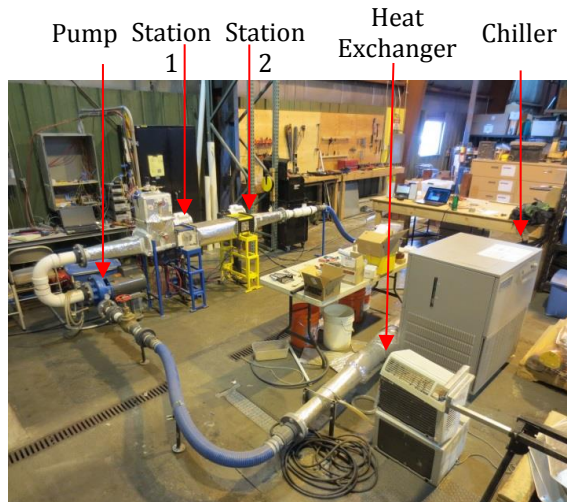
FIGURE 1: VIEW OF THE ENTIRE FLUME.

A custom testing apparatus was designed and built for conducting this study. The testing apparatus consisted of a closed flume that included two test stations, inlet and outlet diffusers, water reservoir, paddle flow meter, and custom built cross-flow heat exchanger as shown in Figure 1.

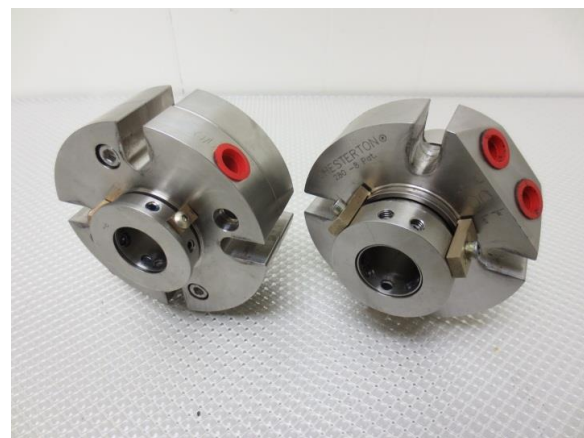
FIGURE 3: THE CHESTERTON 180 HEAVY DUTY CARTRIDGE SINGLE SEAL (LEFT) AND THE CHESTERTON 280 HEAVY DUTY CARTRIDGE DUAL SEAL (RIGHT) TESTED IN THIS STUDY [12].

Water was circulated through the flume at a rate of 1136 liters per minute and maintained at a temperature of 7.22 degrees Celsius using the heat exchanger. In order to prevent water from leaking from test stations, mechanical seals with single contact surfaces and double contact surfaces were installed (Figures 2 and 3). It may be noted that a double cartridge seal, as the name suggests, has two (inner and outer) sealing surfaces (as compared to a single cartridge), and it continues to perform its function should the outer ring fail. This allows replacement of seal before catastrophic failures in the downstream of the system occur from leaking water. Due to this fail-safe feature, the double cartridge seals have emerged as an attractive alternative over single cartridge seals, and therefore, were included in this study.

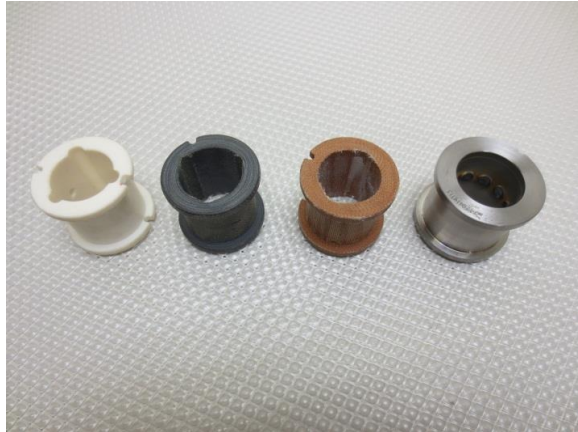
FIGURE 4: THE FOUR CANDIDATE BEARINGS TESTED IN THIS STUDY, FROM LEFT TO RIGHT - VESCONITE, CIP MARINE, FEROFORM T814, AND POLYCRYSTALLINE DIAMOND (PCD) RADIAL BEARING [12].

Four types of bearings were tested; Polycrystalline diamond, CIP Marine, Feroform T814, and Vesconite Hilube. Each test lasted for a total of 60 hours in fresh clean water. This duration was long enough to allow measureable wear on bearings and was considered equivalent to a 60 hrs of in-field performance at peak loading conditions. Figure 4 shows the candidate bearings. Bearings were selected for testing based on recommendations from experts in marine hydrokinetic devices. Table 1 displays types of materials used for shaft and bearing support and co-efficient of friction (wet and/or dry) for each bearing type.

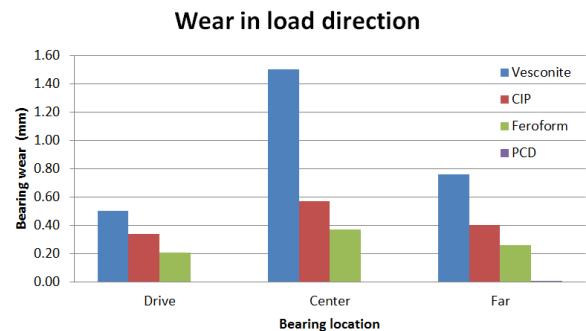
FIGURE 5: WEAR OF EACH BEARING IN THE LOAD-BEARING (VERTICAL) DIRECTION.

Figures 5 and 6 display the total wear on the inner diameter of each bearing tested in the load-bearing (vertical) and water flow (horizontal) directions, respectively, after 60 hours of testing in fresh clean water. The wear on the bearings was measured using internal telescopic gauges and micrometers. As expected, the center bearings which were exposed to the highest pressure-velocity (1.36 MPa-m/s) experienced the highest amount of wear as compared to drive and far side bearings with roughly half the pressure-velocity values of the center bearing. The PCD bearings experienced the least amount of wear among the candidate bearings followed by Feroform T814, CIP Marine, and Vesconite, respectively. The far side Vesconite bearing experienced slightly more wear in the load-bearing direction than the drive side and center bearings in the load direction. In the flow direction, far side Vesconite bearing showed less wear as compared to Feroform T814 and CIP Marine bearings. These deviations may be attributed to misalignment of the shaft during the Vesconite bearing test. It may be noted that the drive side PCD bearing showed a negative value of wear in the flow direction. The reason of this anomaly is probably due to the deposition of wear particles on PCD inserts or some metrological error or uncertainty in wear data.

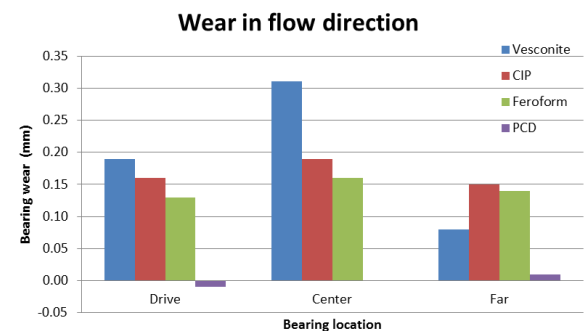
FIGURE 6: WEAR OF EACH BEARING IN THE FLOW (HORIZONTAL) DIRECTION.

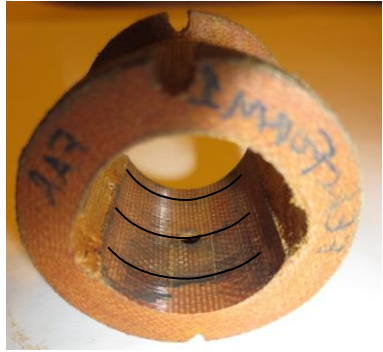
FIGURE 9: THE LOAD (WORN) SURFACES OF FEROFROM T814 BEARINGS AFTER THE TEST. (A) DRIVE SIDE BEARING; (B) MIDDLE BEARING; (C) FAR SIDE BEARING. THE CIRCULAR WEAR PATTERN IS HIGHLIGHTED BY CURVED LINES.

Figures 7-10 show the worn side of each bearing after the test. The polymers bearings (Vesconite, Feroform T814, and CIP Marine) exhibited a circular wear pattern (i.e. circular grooves travelling on the bearing surface along the circumferential direction normal to the axis of the shaft as highlighted through curved lines) on the load contact surface similar to those commonly observed in full scale hydrokinetic bearings in field [13]. The circular marks, as expected, were more pronounced on the middle bearings. The bearing surfaces for each polymer bearing showed dark regions primarily along the main longitudinal grooves, which may be attributed to the accumulation of worn particles in those areas. In PCD bearings, due to miniscule wear, the visual inspection didn't reveal any distinctly identifiable wear pattern.

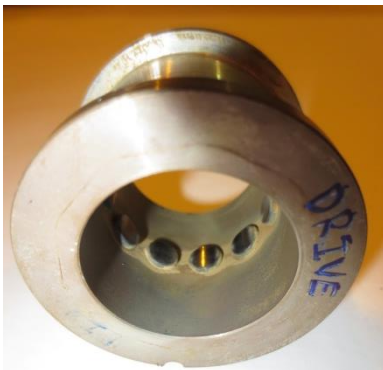
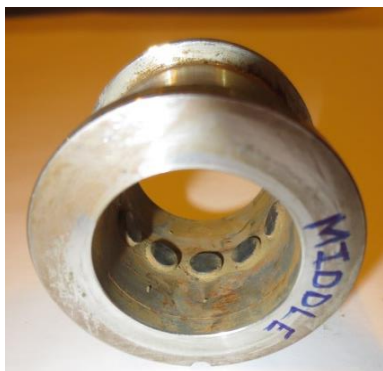
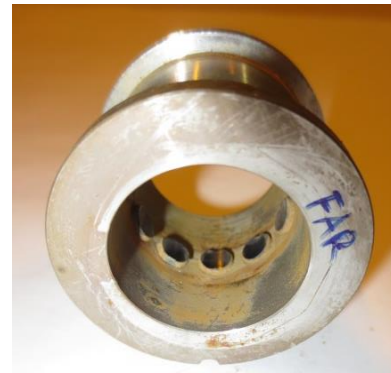
FIGURE 10: THE LOAD (WORN) SURFACES OF PCD BEARINGS AFTER THE TEST. (A) DRIVE SIDE BEARING; (B) MIDDLE BEARING; (C) FAR SIDE BEARING.
