## CRITICAL REVIEW OF ANTI-FOULING STRATEGIES USED ON MARINE RENEWABLE ENERGY CONVERTERS DEPLOYED IN REAL SEA CONDITIONS

The European Marine Energy Centre (EMEC) undertook a critical review investigating biofouling on marine energy converters and their associated systems to formulate mitigation recommendations. The investigation used operational data collected from the EMEC test sites including deployments of EMEC's own equipment as well as that of developers' when testing their wave or tidal energy converters. A questionnaire was sent out to developers to gather further details and specifications on anti-fouling mechanisms used, application methodology and success rate. The study considered the approach to dealing with biofouling by looking at specific components of different materials that had been treated or left untreated and if left untreated, the reasoning. The study recorded the different coatings used, on which materials they were applied, the conditions they were deployed in (water depth, deployment duration, etc) and evaluated the effectiveness of these coatings. In some cases, anti-fouling strategies other than applying coatings were used and where this was the case, th

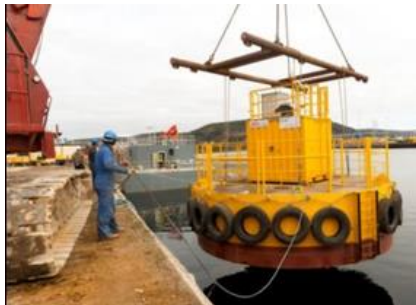
Figures 1 and 2 give an insight into the study, showing the EMEC Test Support Buoy (TSB) before and after deployment which had been coated with Jotun paint for the antifouling protection. The duration of the deployment was 6 months over spring and summertime which resulted in low levels of biofouling as seen in figure 2.

FIGURE 1 - EMEC TSB BEFORE DEPLOYMENT      FIGURE 2- EMEC TSB AFTER DEPLOYMENT
